Use, Land Occupation and Environmental Impacts on São Marcos Beach, São Luís, Brazil

ABSTRACT

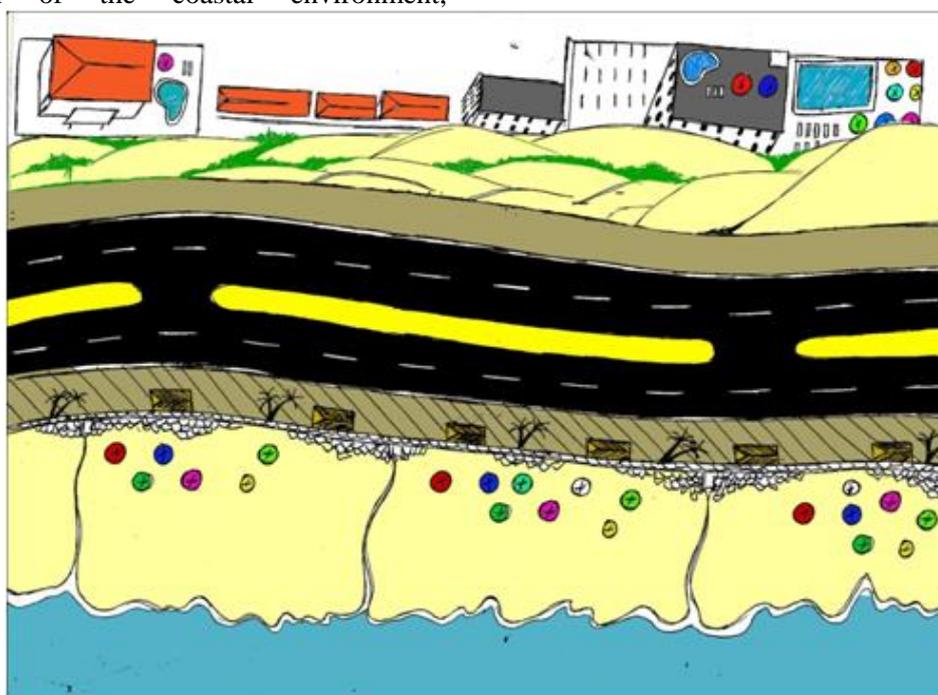
Figure1. Configuration diagram of São Marcos Beach. (SOURCE Joherbeth Rêgo)

In the urbanization of São Marcos beach, the paleodunes and, consequently, part of its vegetation were preserved, despite Avenida Litorânea running parallel to the beach. There was some concern in maintaining some beach aspects, which was not observed on other beaches on the island of Maranhão. The characteristics described are shown in Figure 01.

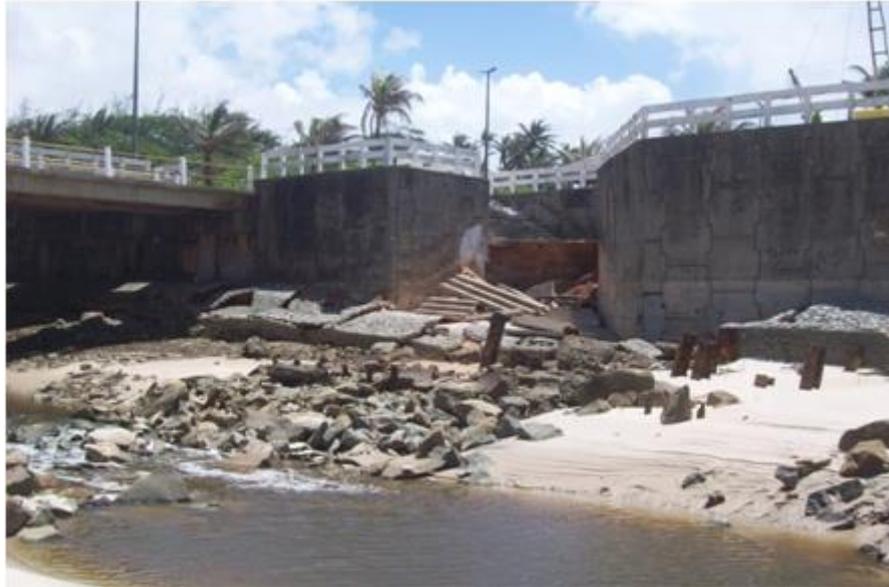
Figure2. Deterioration of human-made construction at the mouth of the Calhau river. (Photo Joherbeth Rêgo)

At the mouth of the Calhau river, one can see how much engineering works have harmed this river course, where previously what should have been riparian forests, strings of dunes and restingas gave way to concrete walls, windings and iron beams exposed in the sand. beach (Figure 02).

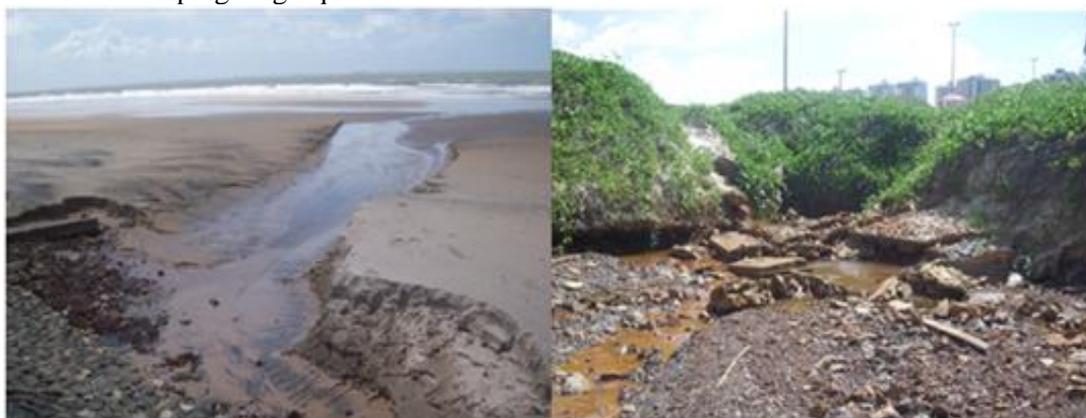
Figure3. Erosion caused by sewage pipes (Photo Joherbeth Rêgo)

Erosion on São Marcos beach is another problem caused, mainly, by the “sewers” which, in addition to dumping large quantities of raw

sewage onto the beach sand, also causes erosion not only in the stretch, but also in the dune ranges. existing areas leaving a trail of erosion and pollution on the beach under study (Figure 03). During the rainy season, due to the force of rainwater, erosion on the beach occurs in a more intense way, eroding the beach sand and the dune ranges.

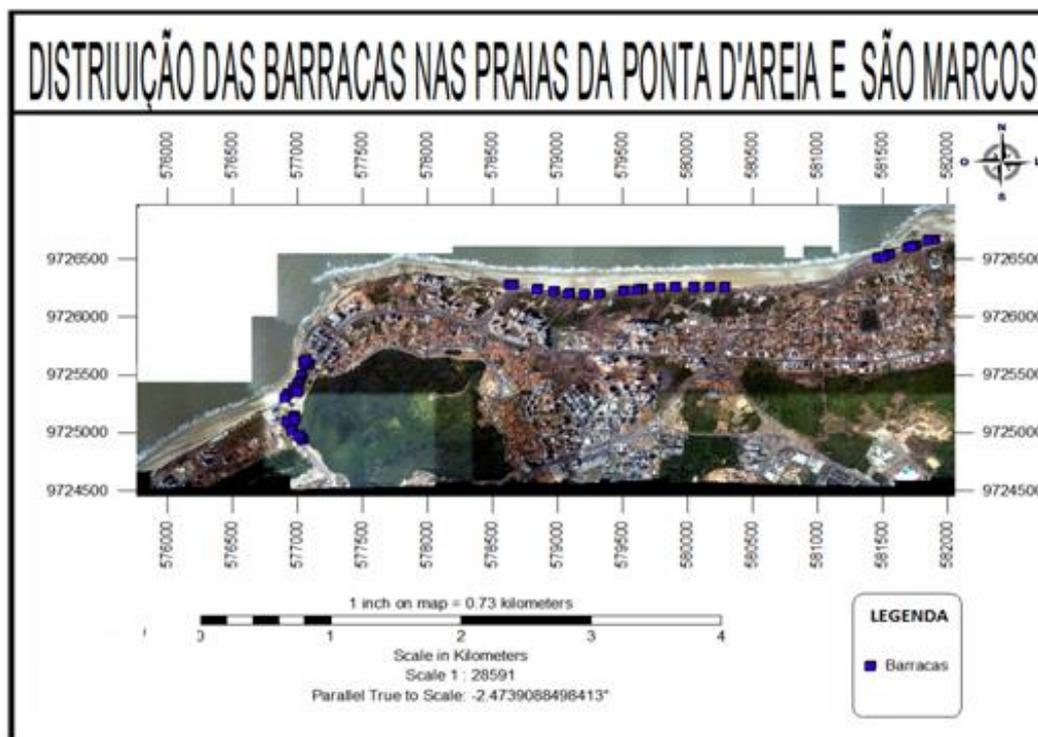
Figure 4. Spatialization of tents in the study area. (Source Google Earth adapted by the author)

From figure 04, the existence of commercial stalls can be identified mainly in the beach environment itself, in the northern portion of the image, which comprises São Marcos beach. These commercial stalls are bars and restaurants standardized by the city hall to carry out their commercial activities.

In the western portion, other commercial stalls are identified, but already on Ponta D'areia beach. An important observation must be made: on this beach the tents are not on the coastal strip, but on the avenue and sidewalks of the place, unlike São Marcos beach. This configuration is due to two supposed factors: the level of urbanization of the area, which is much older compared to São Marcos beach, and the

size available for use of the site, which is smaller compared to São Marcos beach. It is observed that the tents are also located on the sidewalks near Laguna da Jansen, but this location is already outside the study area.

The Union's heritage superintendence has been taking action against all the stalls on Avenida Litorânea since 2009 where all the bar owners removed the additions built by default and if they did not remove them, the SPU would demolish all the irregular structures, but the association of micro-entrepreneurs on the avenue Litorânea obtained an injunction suspending the demolitions (BRASIL, 2010). This action continues through the courts to this day without any definition and work continues in some bars to expand their establishments further and further into the beach.
